2021

ECOSYSTEM MONITORING REPORT

CRACKATUXET POND

GREAT POND FOUNDATION

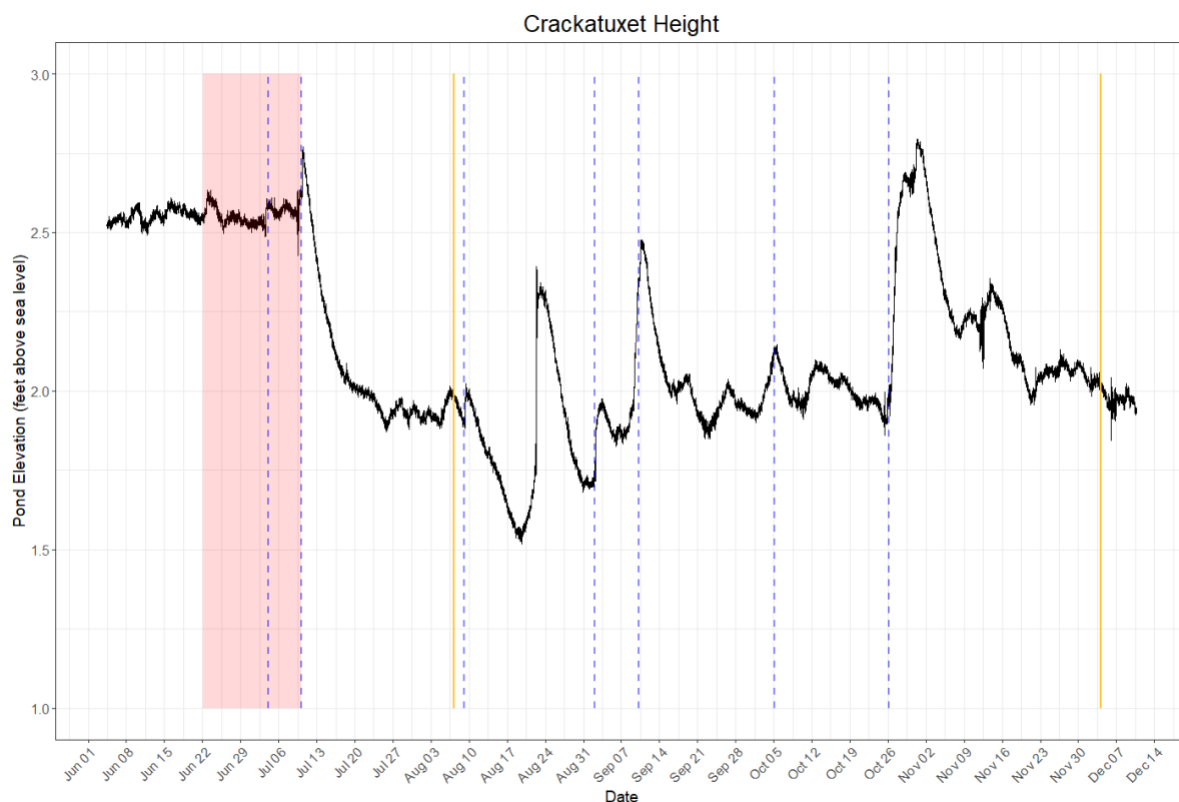
The elevation of Crackatuxet Pond was continuously monitored via a water level logger deployed in the Pond. This data logger measures pond height relative to sea level and collects data every 30 minutes (Figure 2). The water level logger was installed in the beginning of June and remains deployed continuously collecting pond elevation data. This data logger is a crucial tool in understanding how water level is impacted by rainfall and how the Pond responds to changes in the water level of EGP.

However, the hydrologic connection to EGP was not limited to groundwater in 2021. GPF observed an anomaly in water level measurements in EGP and CRX in late June which suggested that water was flowing between the two ponds through the sluiceway. A GPF site visit to the sluiceway on July 9 confirmed that boards were missing in the sluiceway. This was immediately brought to the attention of the Edgartown Shellfish Department, who reinstalled the boards on July 10. Data from the water level loggers indicate that these boards were removed on approximately June 22, resulting in at least 2 weeks of surface water exchange with EGP (red box in Figure 2). Since the elevation of EGP was high, around 2.8 feet above sea level, this resulted in EGP draining into CRX. The drainage of EGP into CRX caused EGP to lose approximately 0.75 feet of elevation, which delayed the summer opening of EGP.

Once the boards were reinstalled by the Shellfish Department, water exchange between the two ponds was cut off. This resulted in a precipitous drop in Crax water level, from approximately 2.75 feet to less than 2 feet (Figure 2). EGP is a much larger pond with a significantly larger watershed compared to CRX. Without this steady supply of water, the CRX water level dropped, likely by draining into Katama Bay via Herring Creek. However, this cannot be confirmed because water flow in Herring Creek is not monitored.

Figure 2. Pond elevation of Crackatuxet Pond in 2021. Data were generated by a water level logger on the northwest shore of the Pond. The solid yellow lines are when EGP was cut to the ocean. The dashed blue lines are when precipitation exceed 1 inch. The red box indicates when the boards to the sluiceway were removed.

Water level in CRX dropped again when EGP was opened to the ocean on August 7 (yellow line in Figure 2). This caused water elevation to drop nearly 0.5 feet over the course of two weeks. As a pond with a smaller volume of water, CRX is highly influenced by changes in water level in EGP. Additionally, rainfall events had a large impact on water elevation in CRX. Each time precipitation exceeded 1 inch (blue dashed lines in Figure 2), CRX water

height subsequently increased, often significantly. Rain events totaling less than 1" in precipitation also impacted the Pond's elevation, however these are not marked on Figure 2. Each spike in pond height is followed by a drop, suggesting the surge of water is flowing out of the pond. To further understand where this water is flowing, a detailed hydrologic study of the area is needed. 2021 was the first year that GPF monitored Crax water height, therefore comparisons to previous years cannot be made.

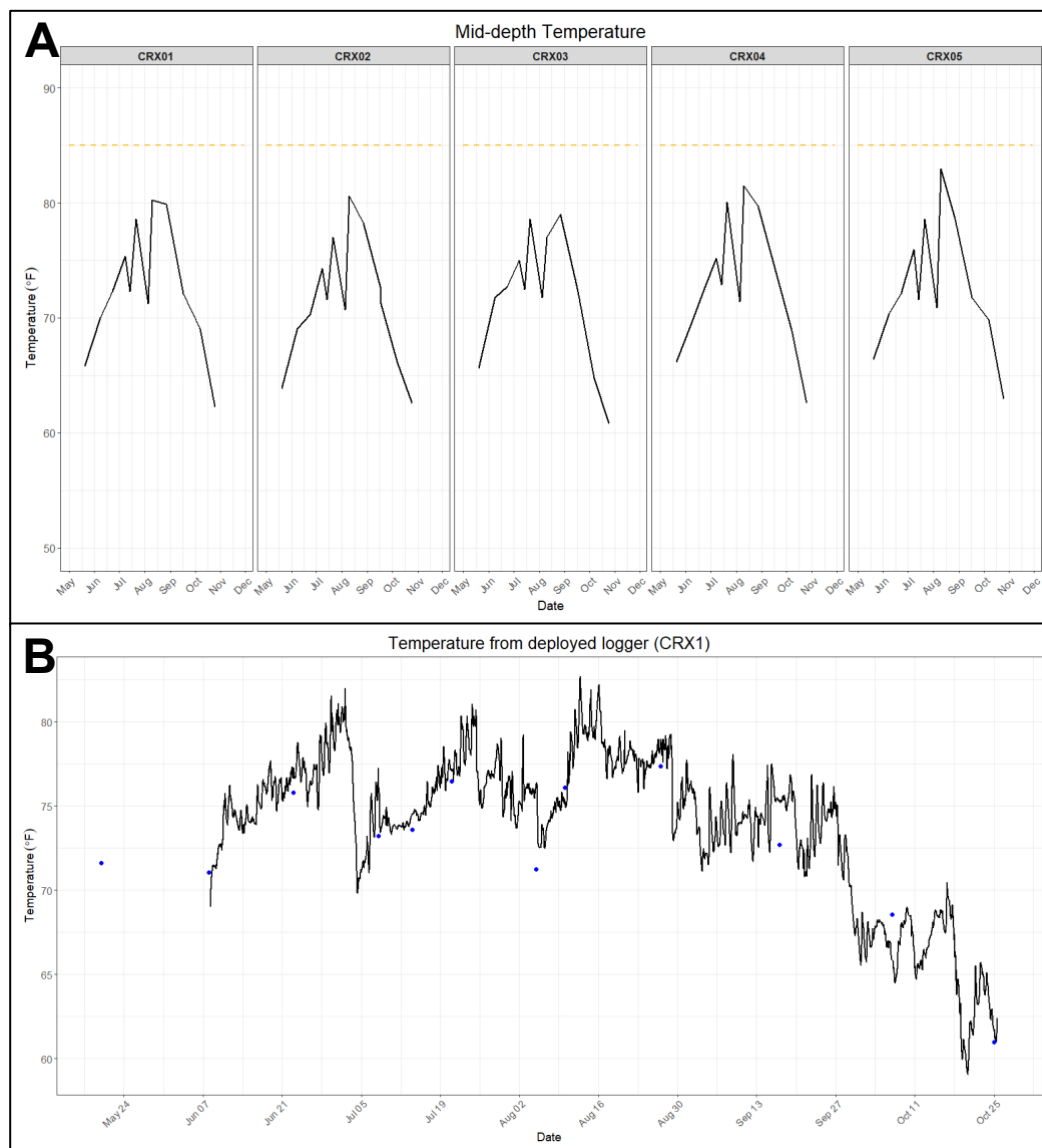
Temperature was measured throughout the water column at all stations across the Pond during site visits. Additionally, bottom water temperature was continuously monitored with a temperature sensor attached to the dissolved oxygen data logger. Maximum water temperature occurred on August 12, where temperatures reached 82.6°F (Figure 5). The site visits on August 27 and July 21 were also noteworthy, with temperatures for both days reaching 80°F. All the stations were very similar in temperature and exhibited the same seasonal trend (Figure 5A).

Figure 5. Water temperature in Crackatuxet Pond in 2021. (A) Temperature measured by a handheld probe at mid-depth at all stations. The dashed yellow line is the 85°F management threshold. (B) Temperature measured via a data logger deployed on the bottom at station CRX1. Blue dots are temperature measured by a handheld probe during site visits.

It is noteworthy that water temperature never exceeded the 85°F threshold. Even in the dataset from the deployed data logger, the maximum temperature was 82.6°F (Figure 5B). Small, shallow ponds such as Crackatuxet Pond often suffer from elevated temperatures in the summer. The health of CRX likely benefited from water temperatures that remained below 85°F.

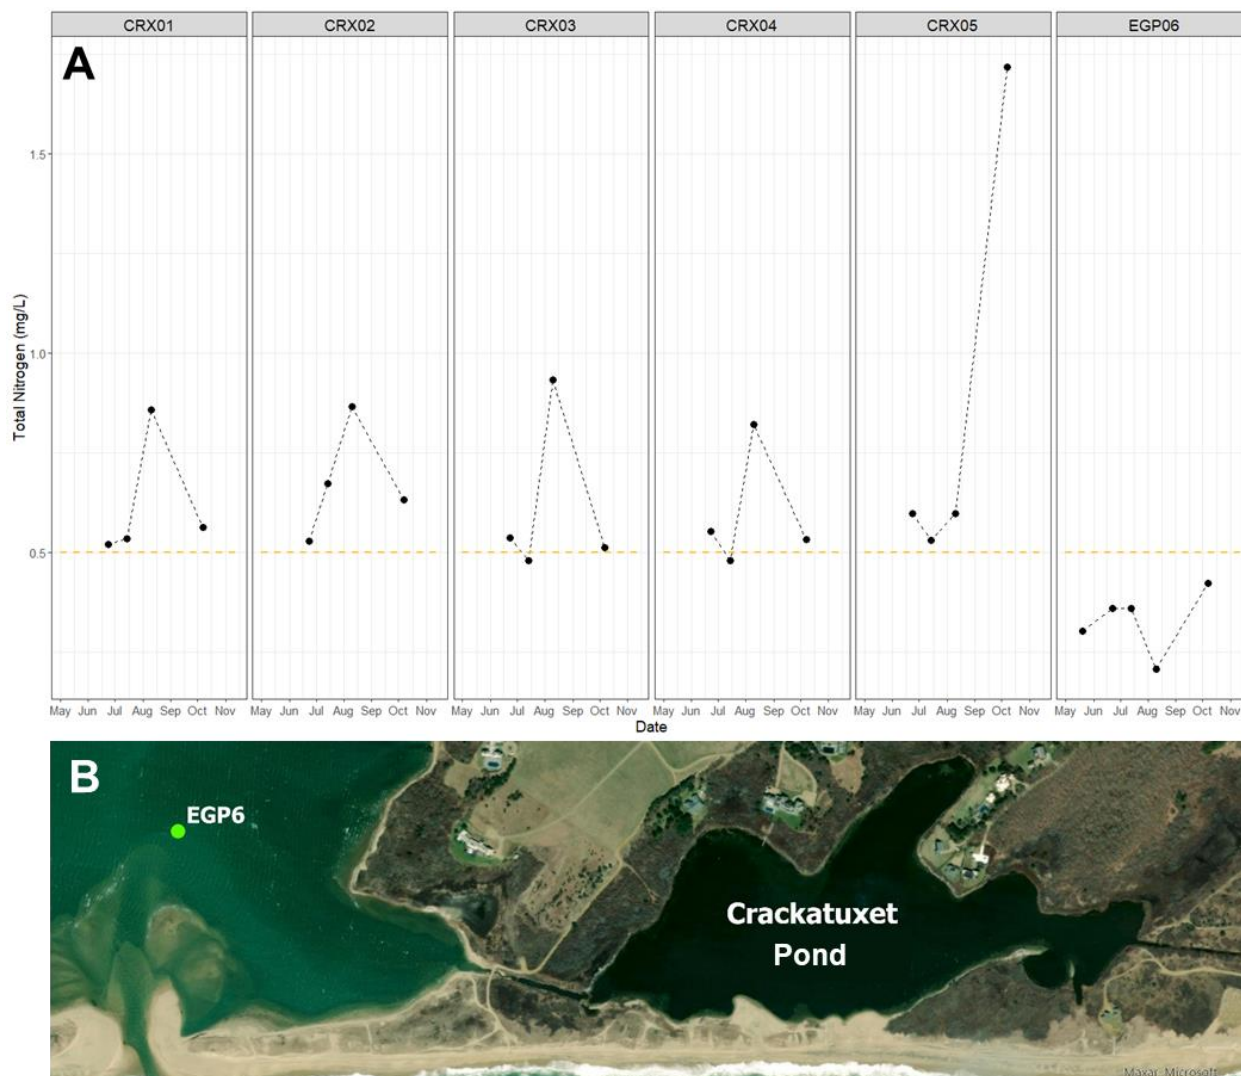
Overall, nutrient concentrations in CRX were elevated, particularly nitrogen concentrations. Total nitrogen (TN) measures both inorganic and organic forms of nitrogen and is the metric typically used to assess whether eutrophication is occurring in coastal ecosystems. In saltwater estuaries, the management target for TN is commonly 0.5 milligrams per liter (mg/L) or lower. The Massachusetts Estuaries Project study on EGP used this threshold, where values under 0.5 mg/L are needed to avoid impairment. In absence of a threshold specific to CRX, the EGP TN target of 0.5 mg/L was used. TN values in CRX were above the 0.5 mg/L threshold for the majority of the monitoring period (Figure 9). The lowest TN recorded was 0.47 mg/L, which occurred on 7/14/2021 at stations CRX3 and CRX4, while the highest TN value was 1.7 mg/L at station CRX5 on 10/7/2021. However, this measurement is unexpectedly high and could potentially be the result of an anomaly in the sampling procedure. Outside of this outlier, the highest TN concentration occurred on 8/10/21 at CRX3, of 0.93 mg/L.

Excluding the outlier at CRX5 on October 7, all Crackatuxet stations followed the same trend and no single station exhibited notably higher nutrient pollution. TN measurements at all stations peaked on August 10, with lower TN values earlier in the summer and in the fall. Regardless of the time of year, all CRX stations had elevated nitrogen levels. With the exception of two measurements of 0.47 mg/L, all other measurements were above the 0.5 mg/L threshold. This indicates that eutrophication is occurring and that the ecosystem is impaired.

Total nitrogen values can be compared to values in EGP, specifically at station EGP6, which is adjacent to the CRX sluiceway (see map in Appendix). All TN measurements for EGP6 were below the 0.5 mg/L threshold (Figure 9). Nutrient concentrations in EGP are reduced after the pond is opened to the ocean, and the August cut likely influenced TN levels at EGP6. Regardless, these nutrient data indicate that Crackatuxet Pond experiences a higher nitrogen load than the adjacent region of EGP.

Figure 9. Total nitrogen in milligrams per liter (mg/L) in 2021. Data are from all 5 CRX sampling stations and station EGP6 for comparison (map in panel B). The dashed yellow line represents the 0.5 mg/L management target for healthy coastal ponds.
