ECOSYSTEM MONITORING REPORT

TISBURY GREAT POND

GREAT POND FOUNDATION
Julie Pringle, Scientific Program Director

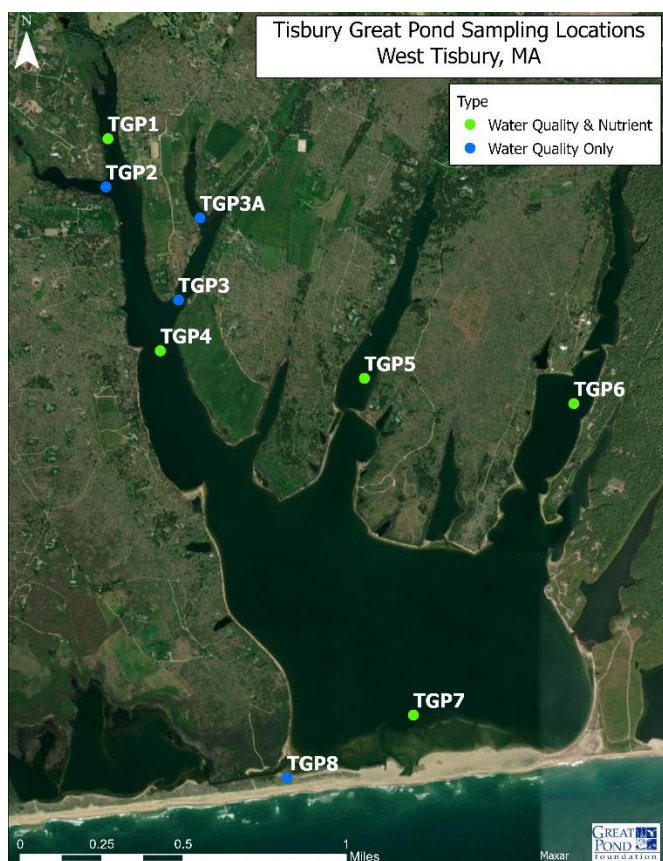
Figure 1. Map of the nine Tisbury Great Pond (TGP) sampling stations.

Data collection was centered on 9 sampling stations throughout the Pond (Figure 1). These water sampling stations cover all geographic features of the TGP ecosystem: adjacent to the barrier beach, near the connecting channel to Black Point Pond, and at least one

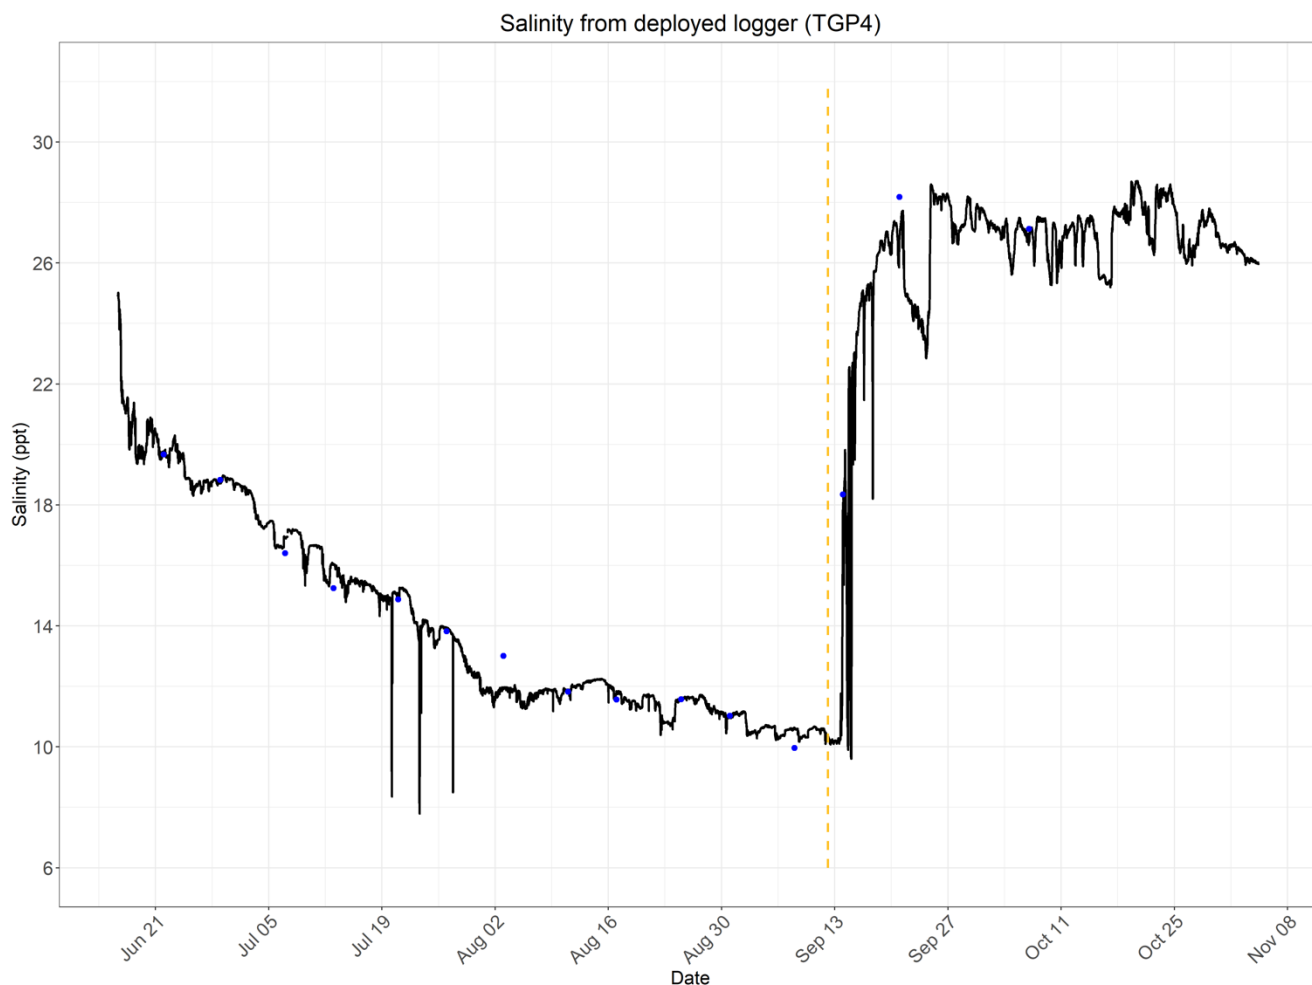
Figure 3. Salinity in parts per thousand (ppt) in 2021. Data were measured with a conductivity/salinity data logger deployed at station TGP4. Blue dots are salinity measured with a handheld probe during site visits. The dashed yellow line is when TGP was cut to the ocean on 9/12/21.

Salinity rapidly increased following pond cuts. While GPF was not monitoring TGP prior to the May 8 cut, salinity at a majority of monitoring stations was typically above 20 ppt at the start of the monitoring period (Figure 2). Salinity gradually decreased throughout the summer to an average of 9.48 ppt on 9/8, 4 days before the September 12 cut. During the period immediately following a cut, fresh groundwater flow into the Pond from the surrounding water table will temporarily increase due to a hydrostatic pressure gradient caused by the rapid draining of the pond. After this initial drop following the September 12 cut, salinity levels jumped to a pond-wide average of 23.5 ppt on 9/21, 9 days after the cut. These trends were also captured by the continuous conductivity logger deployed at station TGP4 (Figure 3).

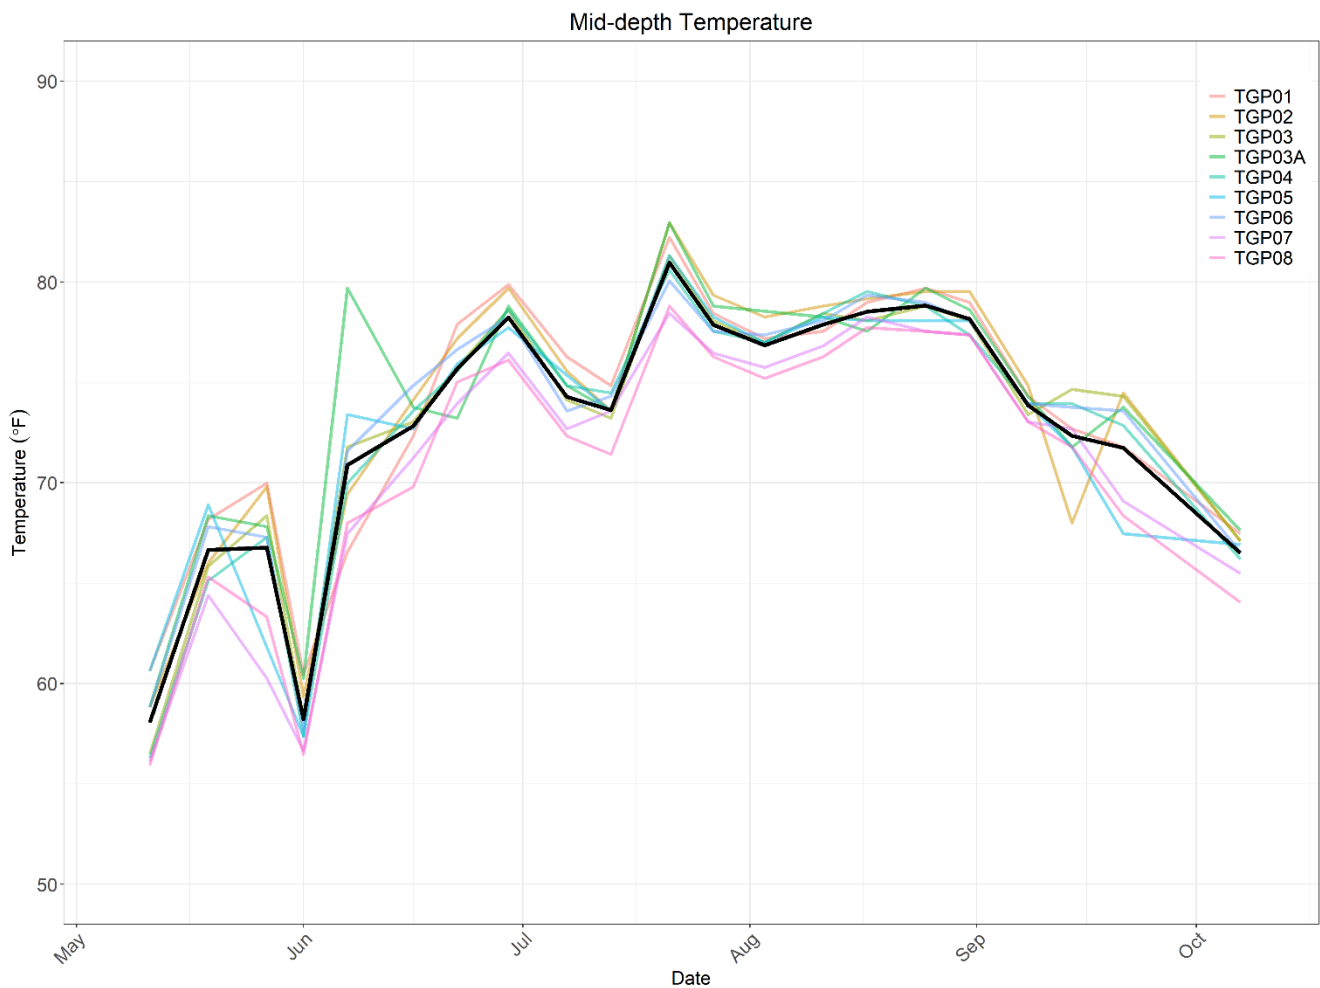
Figure 4. Temperature in Tisbury Great Pond in 2021. Colored lines represent data from the different sampling stations, and the black line is the pond-wide average temperature for each site visit.

temperatures reached 83.1°F at station TGP3A (Figure 4), while average mid-depth temperature for the entire pond was 80.96 °F on the same day. Other notably higher temperatures were observed on June 29, August 17, and August 25, with average measurements reaching 80°F on these dates. All stations were fairly similar in temperature relative to each other and exhibited the same seasonal trend (Figure 4). Stations TGP7 and TGP8 were consistently cooler throughout the sampling period, likely due to their location within the main basin and their proximity to the ocean.

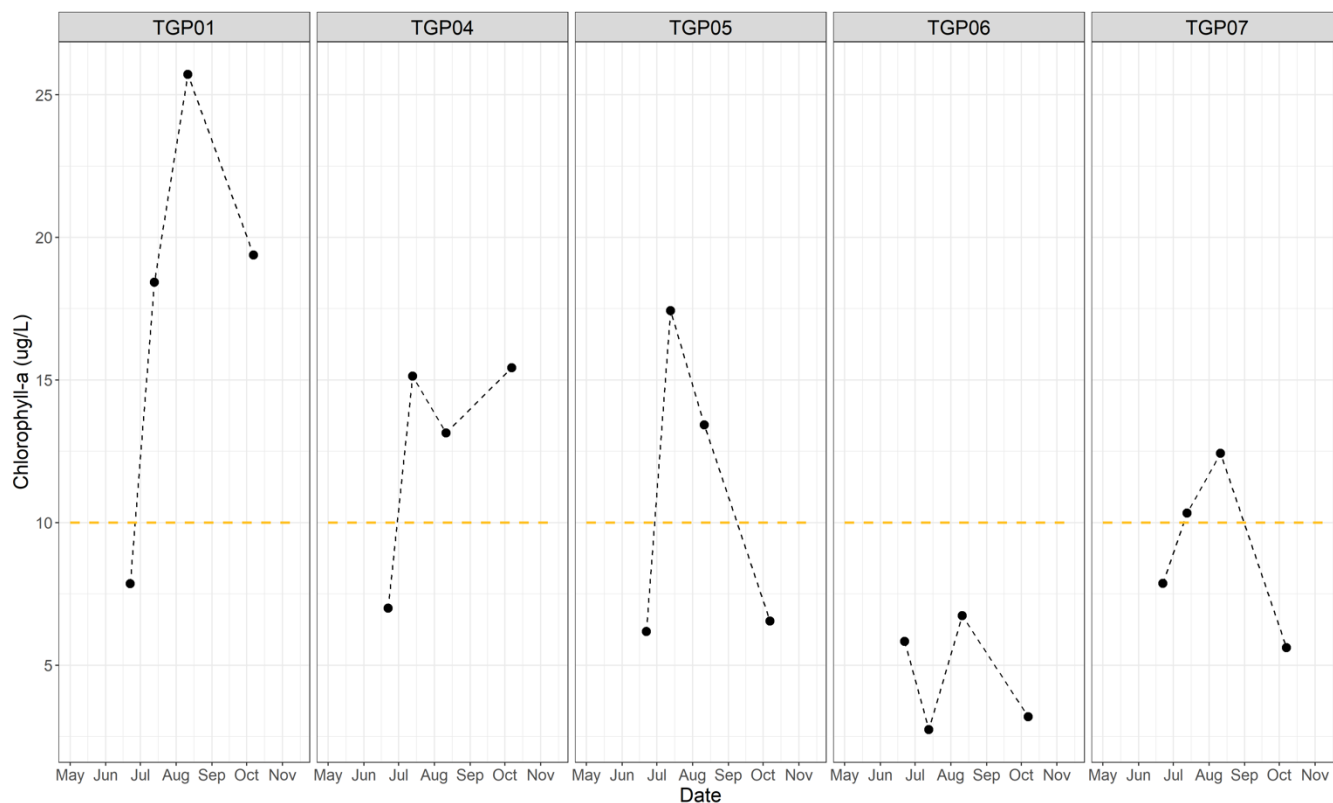
Figure 11. Chlorophyll-a pigments in micrograms per liter ($\mu\text{g/L}$) in 2021. Data are from 5 TGP sampling stations. The dashed yellow line represents the 10 $\mu\text{g/L}$ management target for healthy coastal ponds.

For most TGP sampling stations, chlorophyll was elevated during the summer (Figure 11). The MEP uses a management target of 10 micrograms per liter ($\mu\text{g/L}$) of chlorophyll-a for coastal ponds, and measurements in excess of 10 $\mu\text{g/L}$ are an indicator of impairment (Howes et al., 2013). Chlorophyll-a was above this 10 $\mu\text{g/L}$ threshold at least twice at all TGP stations except TGP7 (Figure 11). Chlorophyll-a concentrations were lowest in June and October and peaked during July and August. This was expected due to hotter temperatures in the summer and increased nutrient inputs from surrounding properties. The maximum observed chlorophyll-a concentration was 25.71 $\mu\text{g/L}$ at station TGP1 on August 11. Stations TGP6 and TGP7 experienced a smaller summer peak in chlorophyll-a measurements, while TGP6 consistently had the lowest chlorophyll measurements and was below the 10 $\mu\text{g/L}$ threshold for all sampling dates (Figure 11). While other TGP stations were occasionally below this target, the peak in the summer indicates that TGP experienced widespread phytoplankton blooms, especially in Town Cove and Tiah's Cove. The lower measurements from Deep Bottom Cove (TGP6) do not preclude the occurrence of a phytoplankton bloom in 2021, as one may have occurred between sample collections. Samples for fluorometric chlorophyll analyses were taken more frequently and at all 9 sampling stations. These measurements were consistently above the 10 $\mu\text{g/L}$ chlorophyll threshold during the summer months for all stations except TGP8.
