2025

ECOSYSTEM MONITORING REPORT

Chilmark Pond

A Year of Restorative Action: Sonic Buoy Deployment and Dredging in 2025

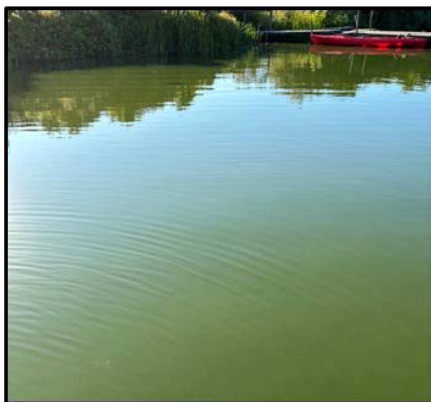
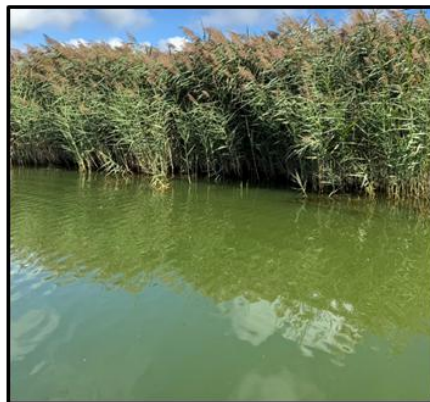
Middle Pond, 9/3/25

Doctor's Creek, 9/3/25

Photos of the bloom can be found in **Figure 4**, where the water looks murky and has a bright-green hue throughout the water column.

Figure 4. Photos of 2025’s *Dolichospermum* cyanobacteria bloom.

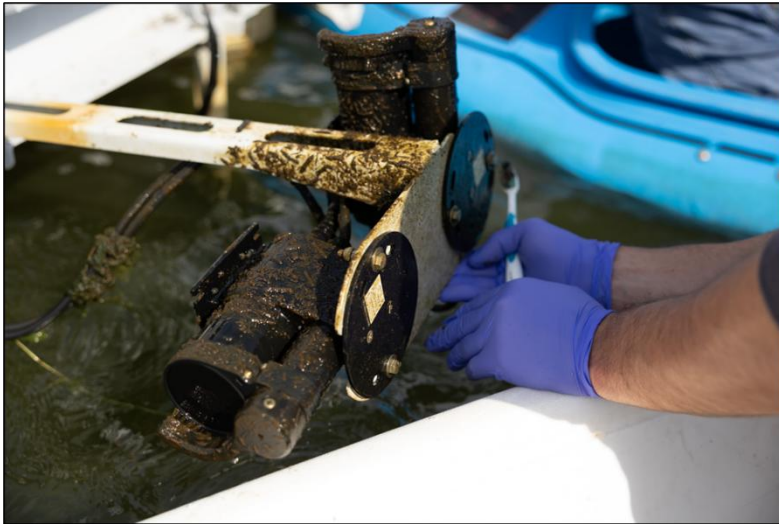
GPF’s staff paddled out to the buoy and pulled up the device’s sonic transmitters, revealing a moderate amount of biofouling (**Figure 6**). A thorough cleaning of the transmitters was performed the same day.

Figure 6. Biofouling on the LG Sonic buoy’s ultrasonic transmitters on 9/23/25. Photo credit: Shenya Leon

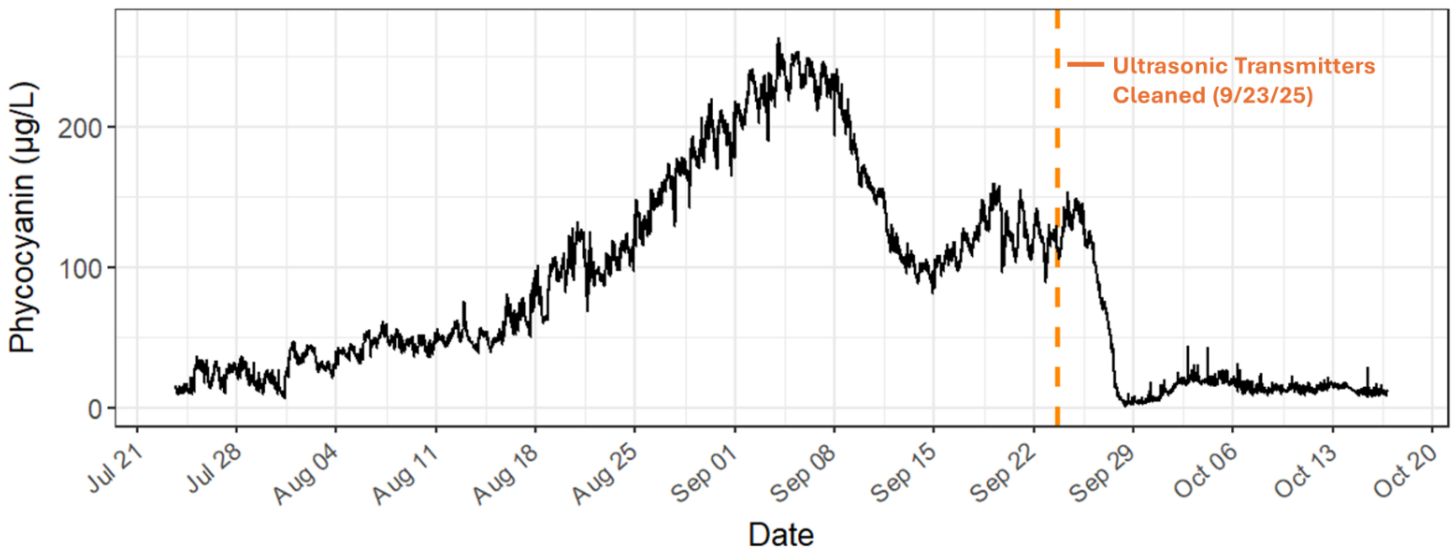
Chilmark Middle Pond: Continuous Phycocyanin 2025

Remarkably, within just 5 days of the transmitters being cleaned, the *Dolichospermum* bloom in the Middle Pond had completely disappeared. This is well illustrated by the continuous phycocyanin measurements logged by the sonic buoy in 2025 (**Figure 7**). Phycocyanin is a pigment unique to cyanobacteria that’s commonly used to measure the abundance of these potentially toxin-producing species. At the time of GPF’s buoy cleaning on 9/23, phycocyanin measurements were especially high ($>100 \mu\text{g/L}$) but had dropped to nearly nothing by 9/28. The dissipation of the bloom in the Middle Pond was accompanied

Figure 7. Continuous phycocyanin measurements (in $\mu\text{g/L}$) in Chilmark Middle Pond in 2025. Data was obtained from the LG Sonic buoy, located roughly 200 feet away from CPF’s CHPUP monitoring station.

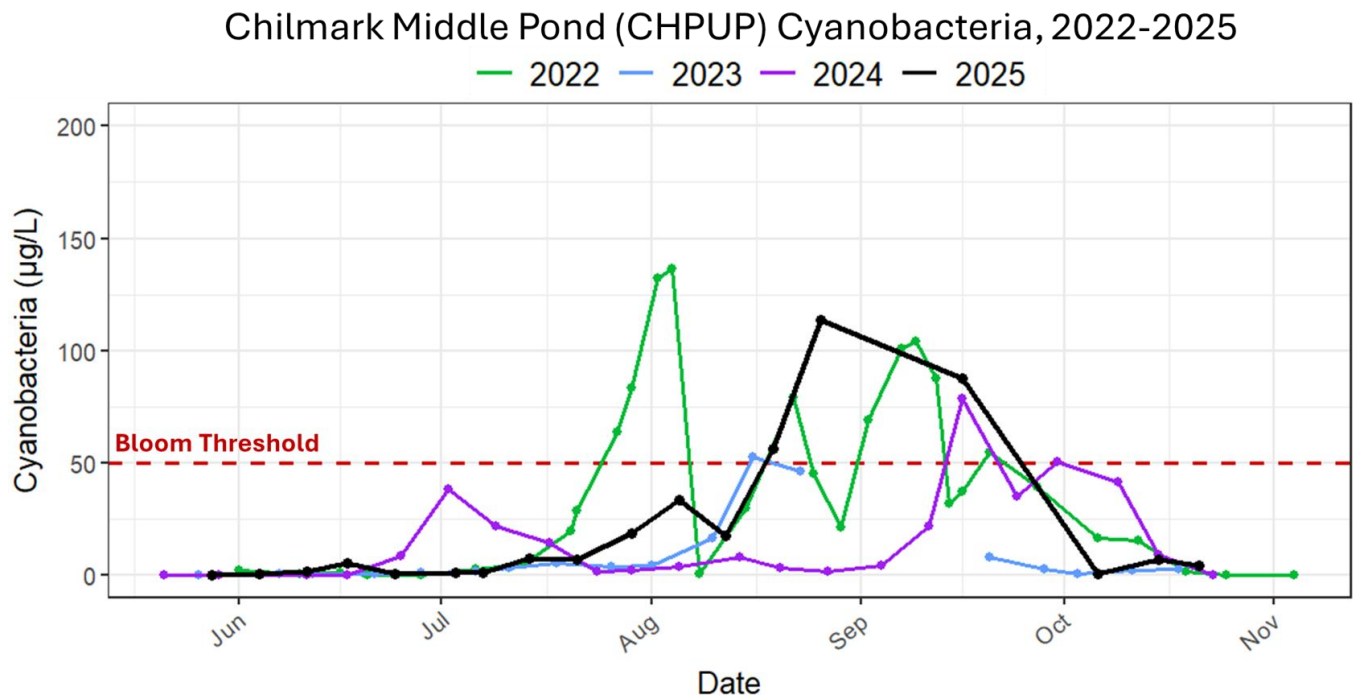
Figure A1. Cyanobacteria concentrations (in µg/L) for Chilmark Middle Pond's CHPUP monitoring station for the years 2022-2025. The dashed red line represents the MV CYANO™ program's bloom threshold (a bloom is considered present when concentrations exceed this limit). Data is missing from 2023's primary bloom period.

Given the relative proximity of this shoreline to the station, GPF opted to include 2025’s shoreline samples in **Figure 5** to provide a higher resolution timeline of cyanobacteria activity in 2025 (refer to **Figure A1** in the appendix for a version of the figure omitting shoreline samples). However, both 2025 datasets (with and without the shoreline samples, respectively) were used to compare bloom stats across years in **Table 1** to eliminate sampling bias. Regardless of whether or not shoreline samples are included, 2025’s *Dolichospermum* bloom exhibited both a similar duration and peak concentration to the blooms of 2022 and 2024 (**Table 1**).

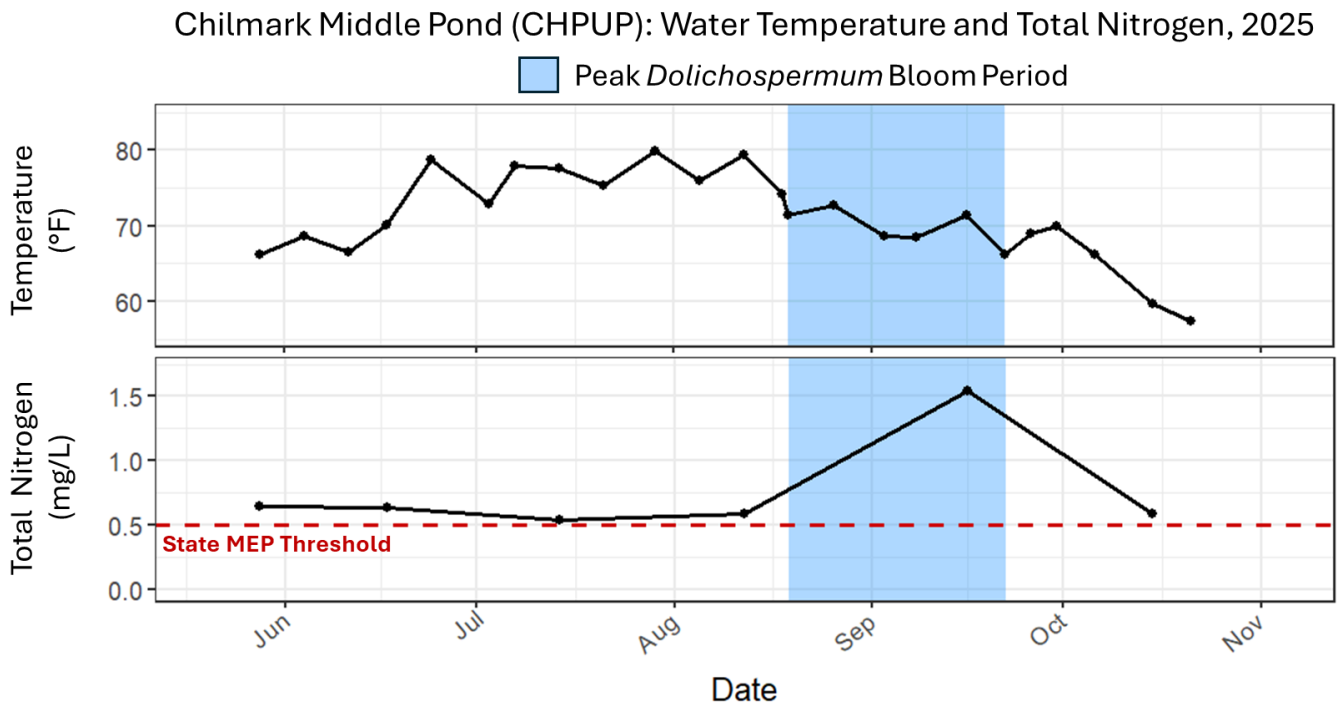
Figure A2. Surface water temperature (in °F) and total nitrogen (in mg/L) for Chilmark Middle Pond's CHPUP monitoring station in 2025. Surface water measurements were taken at the adjacent shoreline on 9/3, 9/8, 9/22, and 9/30. The dashed red line on the nitrogen graph represents the State's 0.5 mg/L threshold, as established by CHP's 2015 Massachusetts Estuaries Project (MEP) report (Howes et al., 2015).

In addition to the buoy going into the water too late, the environmental conditions present in the Middle Pond during the late summer of 2025 were highly conducive to *Dolichospermum* growth. In CPF’s 2024 ecosystem monitoring report, it was established that late summer *Dolichospermum* blooms are likely to develop in the Middle Pond when water temperatures are beginning to cool and total nitrogen levels exceed the State’s 0.5 mg/L limit (CPF, 2025). This owes to *Dolichospermum*’s ability to outcompete other species of cyanobacteria at lower water temperatures (Zhang et al., 2020; Deng et al., 2024), especially when excessive amounts of nitrogen (a limiting nutrient) are present (Liu et al., 2024). In September of 2025, total nitrogen levels in the Middle Pond were measured at 3 times the State limit while water temperatures were simultaneously cooling, providing *Dolichospermum* with optimal growing conditions (see **Figure A2** in the Appendix).
