# ECOSYSTEM MONITORING REPORT

## EDGARTOWN GREAT POND

GREAT POND FOUNDATION

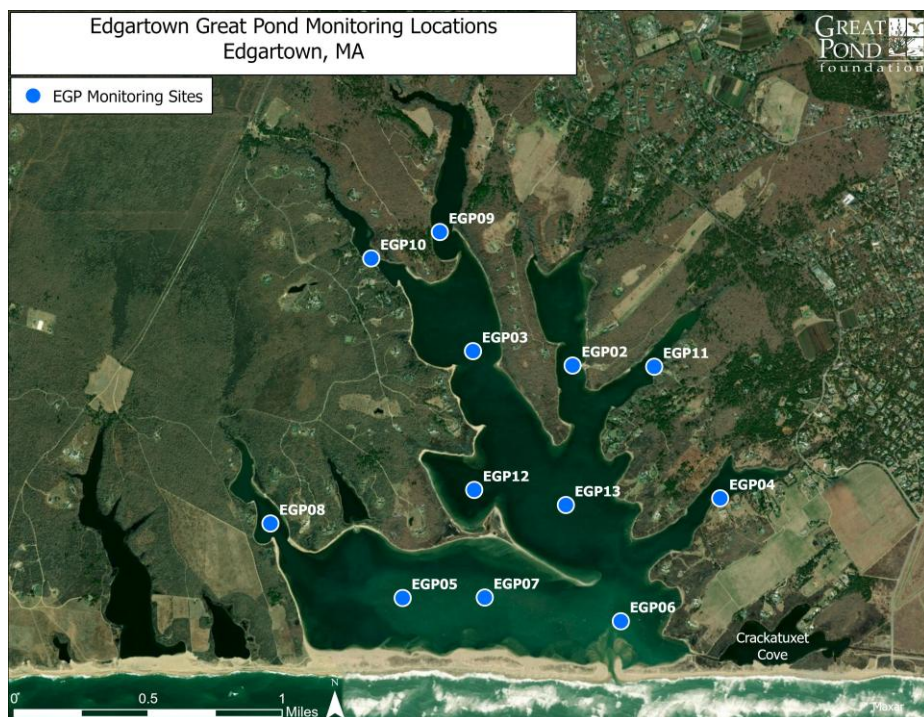
In 2024, Great Pond Foundation (GPF) continued its ecosystem monitoring program on EGP for the 9<sup>th</sup> consecutive year. A total of 26 weekly monitoring trips were conducted between May and October. During each trip, water quality data was obtained for 12 monitoring sites (see map to left). Nutrient samples were collected at 8 of the regular 12 monitoring sites once a month.

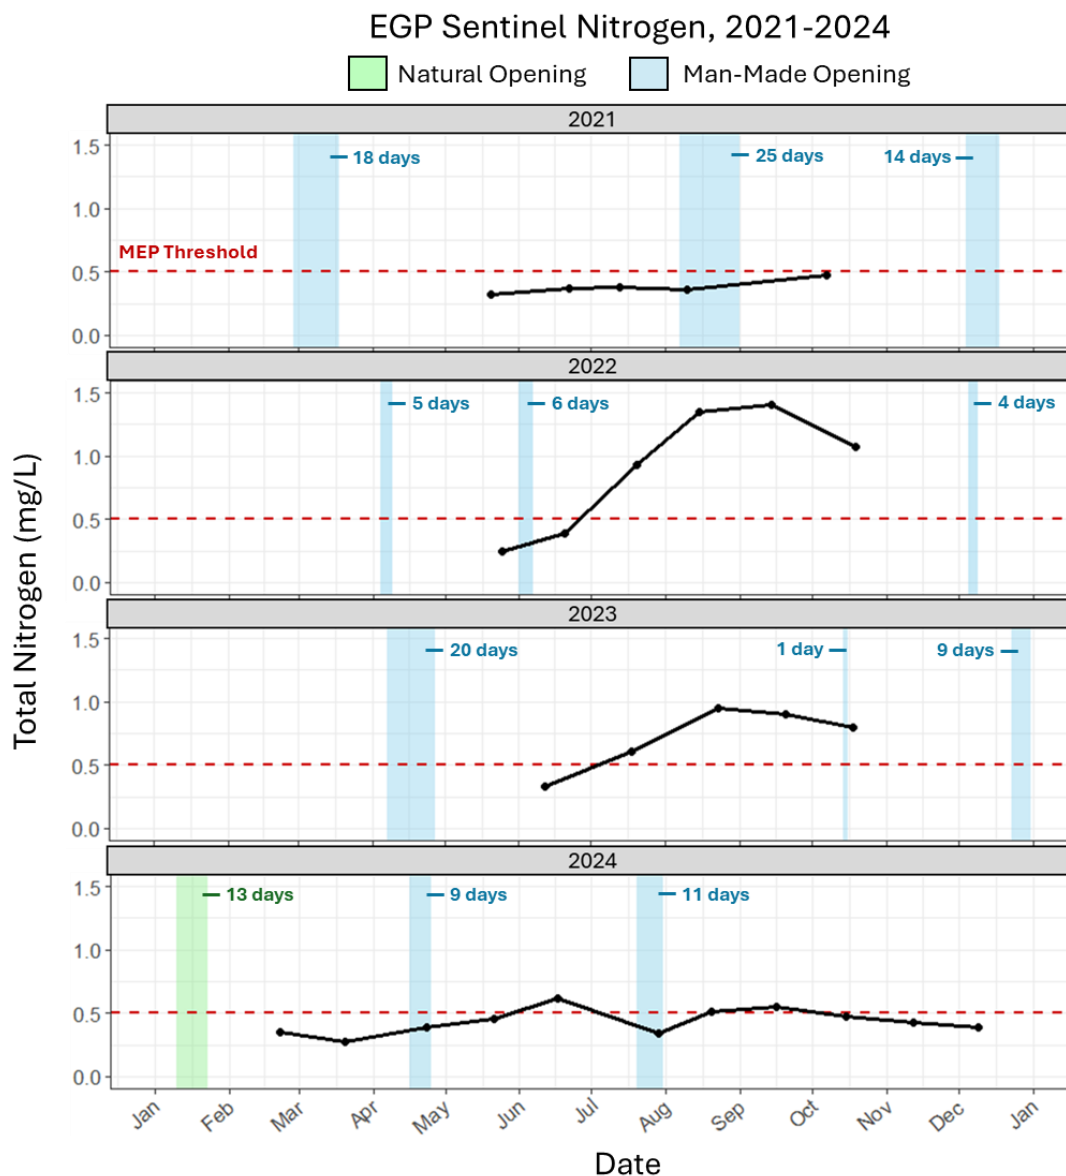
**Figure 4.** Total nitrogen for the EGP “sentinel station” (average of stations EGP02, EGP03, EGP05, EGP06, and EGP09) for the years 2021-2024. Dashed red lines represent the States’ 0.5 mg/L management threshold.

Data going back to 2021 suggests that the timing and duration of openings prior to and during the summer season may play an important role in regulating summer pond health in EGP (**Figure 4**). Summer nitrogen levels in 2024 were the lowest observed in the Pond since 2021. In comparing cut

trends between these 2 years, both 2021 and 2024 experienced long-lived openings ( $\geq 9$  days) during both the spring and summer, respectively. These trends can be contrasted to 2022, EGP's worst year of nitrogen impairment, in which EGP experienced 2 short-lived openings ( $\leq 6$  days) in the spring. In looking at 2023, an intermediate year of nitrogen impairment, EGP experienced a long-lived 20-day opening in the spring but never saw a summer opening. These trends ultimately suggest that frequent, effective flushes of the Pond can serve to lower nitrogen inventories in EGP, with summer nitrogen mitigation being maximized when long-lived openings occur during both the spring and summer.

GPF conducted a pilot nutrient study during the offseason of 2024 to better establish how nitrogen levels in EGP vary across the entire calendar year. These data can be seen in the bottom graph of **Figure 4**, where monthly nitrogen data is available for each month from February to December, expanding beyond the typical May to October sampling regime. Mean TN in EGP never exceeded the State's 0.5 mg/L management threshold during any offseason sampling run (Feb-Apr, Nov-Dec). Given that offseason data only exists for 2024, it's unclear whether these same trends (low TN during winter/spring, high TN during summer, declining TN during fall) are typical. Regardless, the data collected through this offseason pilot study have established a baseline that will allow for future comparison with additional offseason nutrient data.

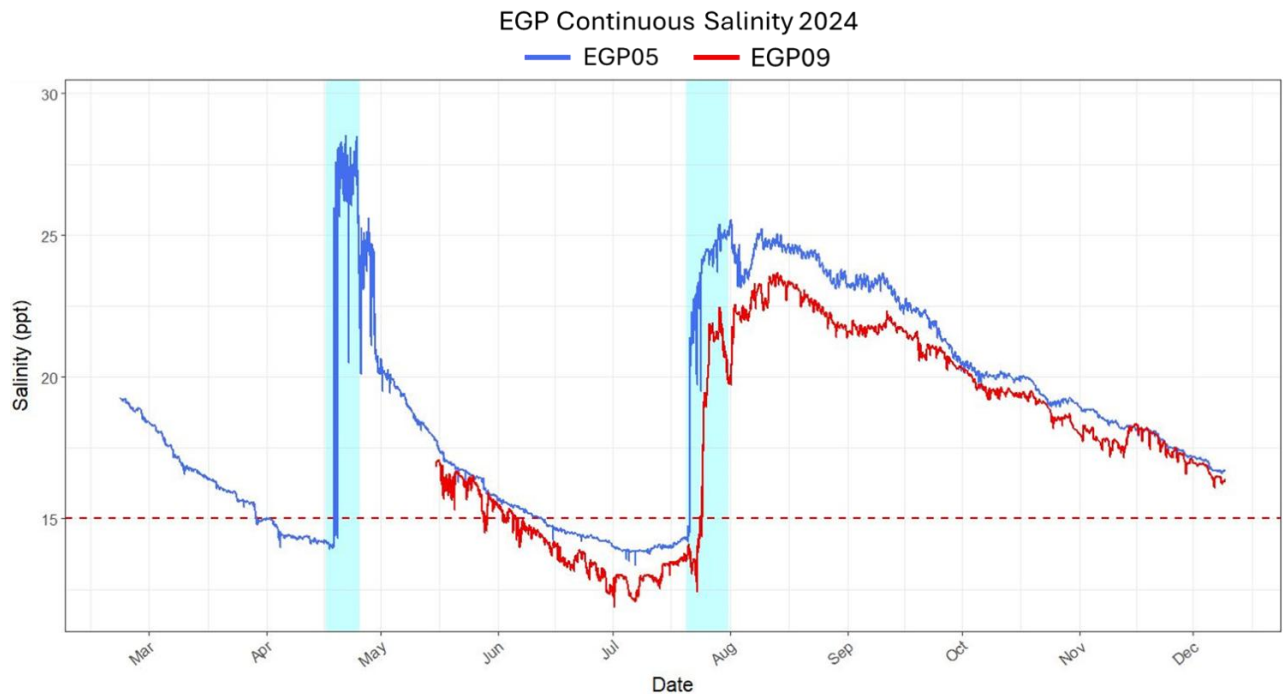
**Figure A3.** Continuous salinity measurements (in ppt) recorded every 30 minutes at monitoring stations EGP05 (southern basin) and EGP09 (Wintucket Cove) in 2024. Shaded blue areas indicate an opening on the Pond. The dashed red line represents the target for maintaining healthy eelgrass beds (15 ppt).

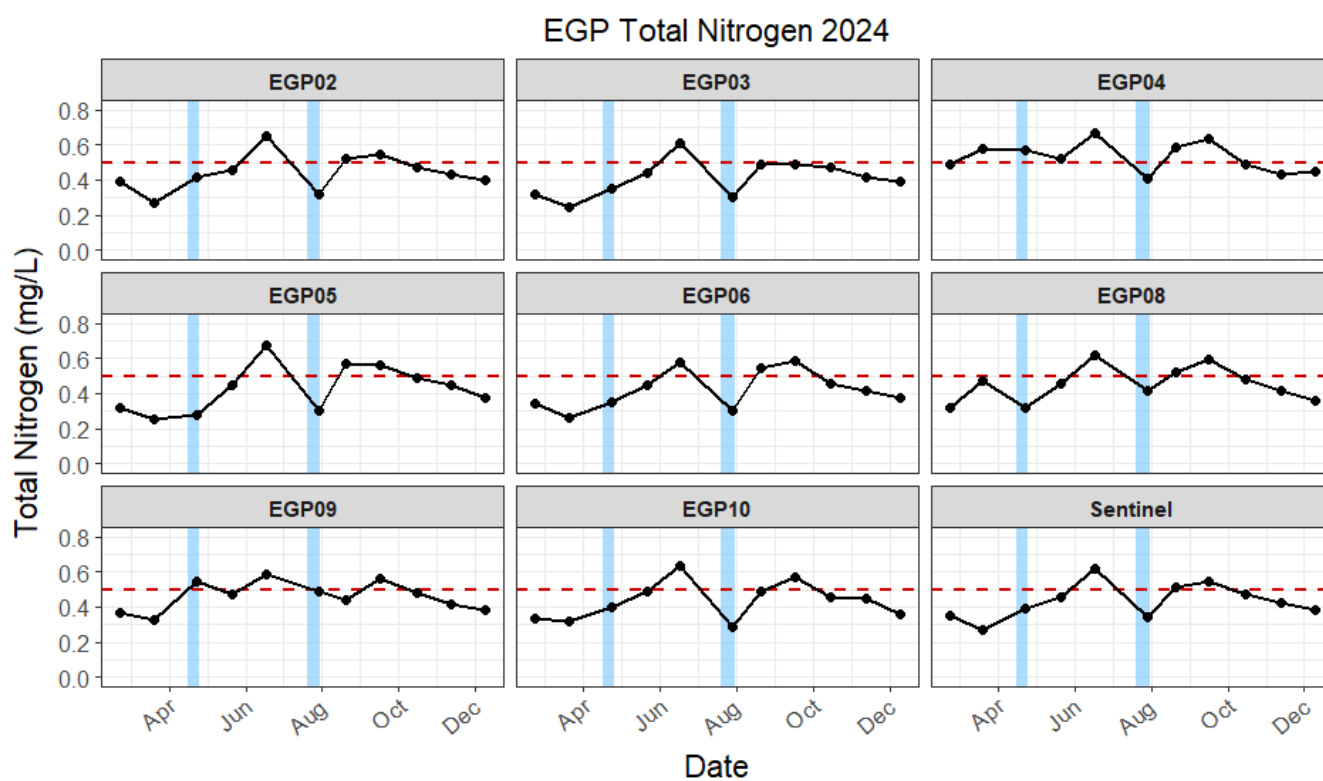
**Figure A10.** Total nitrogen (in mg/L) for EGP's 8 nutrient monitoring stations and the "sentinel station" (average of EGP02, EGP03, EGP05, EGP06, & EGP09) in 2024. The dashed red line represents the State's management threshold (0.5 mg/L). Blue shading indicates an opening on the Pond.

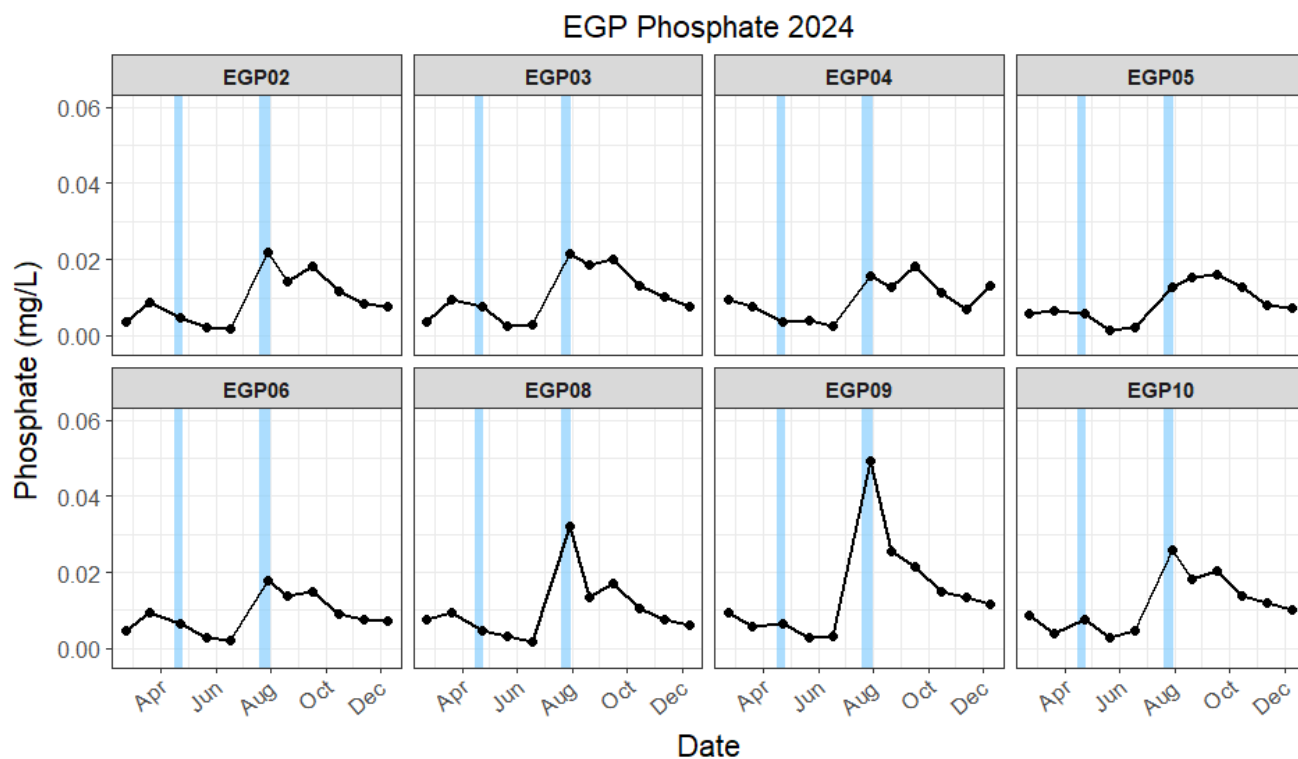
**Figure A11.** Phosphate (in mg/L) for EGP's 8 nutrient monitoring stations in 2024. Blue shading indicates an opening on the Pond.
